INDOOR AIR QUALITY ASSESSMENT

**Solmonese Elementary School
315 West Main Street
Norton, MA 02766**

Prepared by:
Massachusetts Department of Public Health
Center for Environmental Health
Emergency Response/Indoor Air Quality Program
July 2005

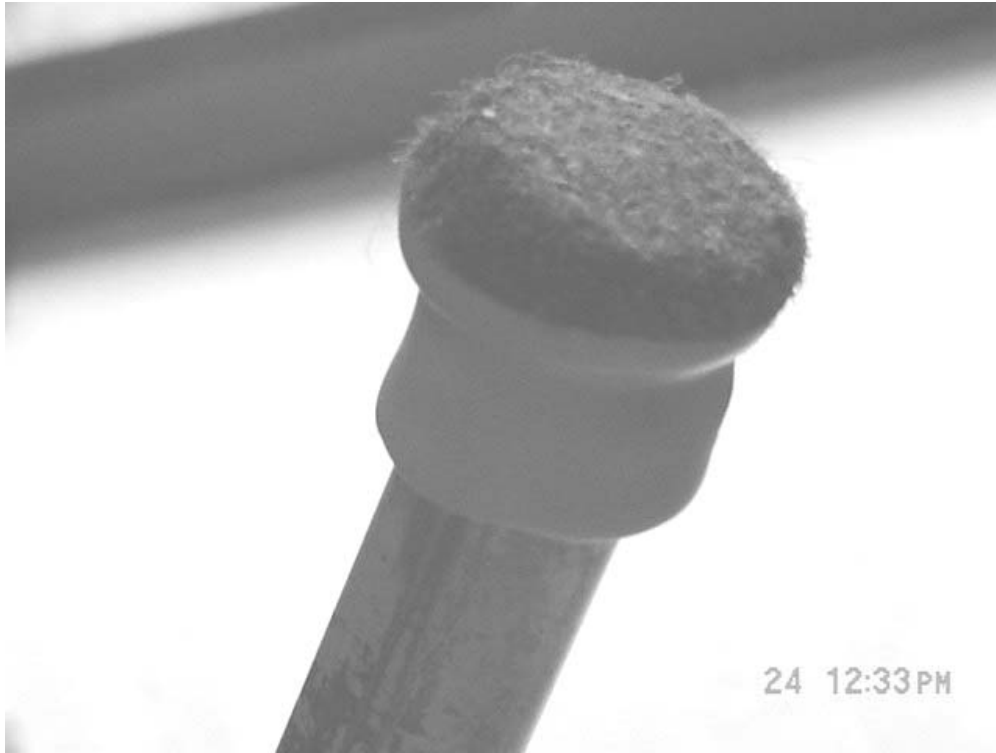
“Glides” for Chair Legs that can be used as an Alternative to Tennis Balls

16. Store cleaning products properly and out of reach of students. Ensure spray bottles are properly labeled in case of emergency.
17. Consider discontinuing the use of tennis balls on furniture and replacing tennis balls with alternative “glides”. Refer to Picture 18 for an example.
